CONSTRUCTION STORMWATER GENERAL PERMIT INSPECTION REPORT

State of Washington Department of Ecology

The Electron Hydro LLC Intake project is covered under the State of Washington's Construction Stormwater General Permit (CSWGP). The CSWGP is a National Pollutant Discharge Elimination System (NPDES) and a State Waste Discharge permit for discharge of construction-related stormwater. The purpose of this inspection was to conduct a compliance inspection with Ecology's new staff, Evan Wood, to provide technical assistance as appropriate, and to continue to make site observations and have discussions regarding the water quality management plan (WQMP). The settling basin and forebay/laydown areas were also viewed, which are not within or near the CSWGP site, but has implications related to hydro operations and sediment management. Follow-up is occurring outside of the CSWGP.

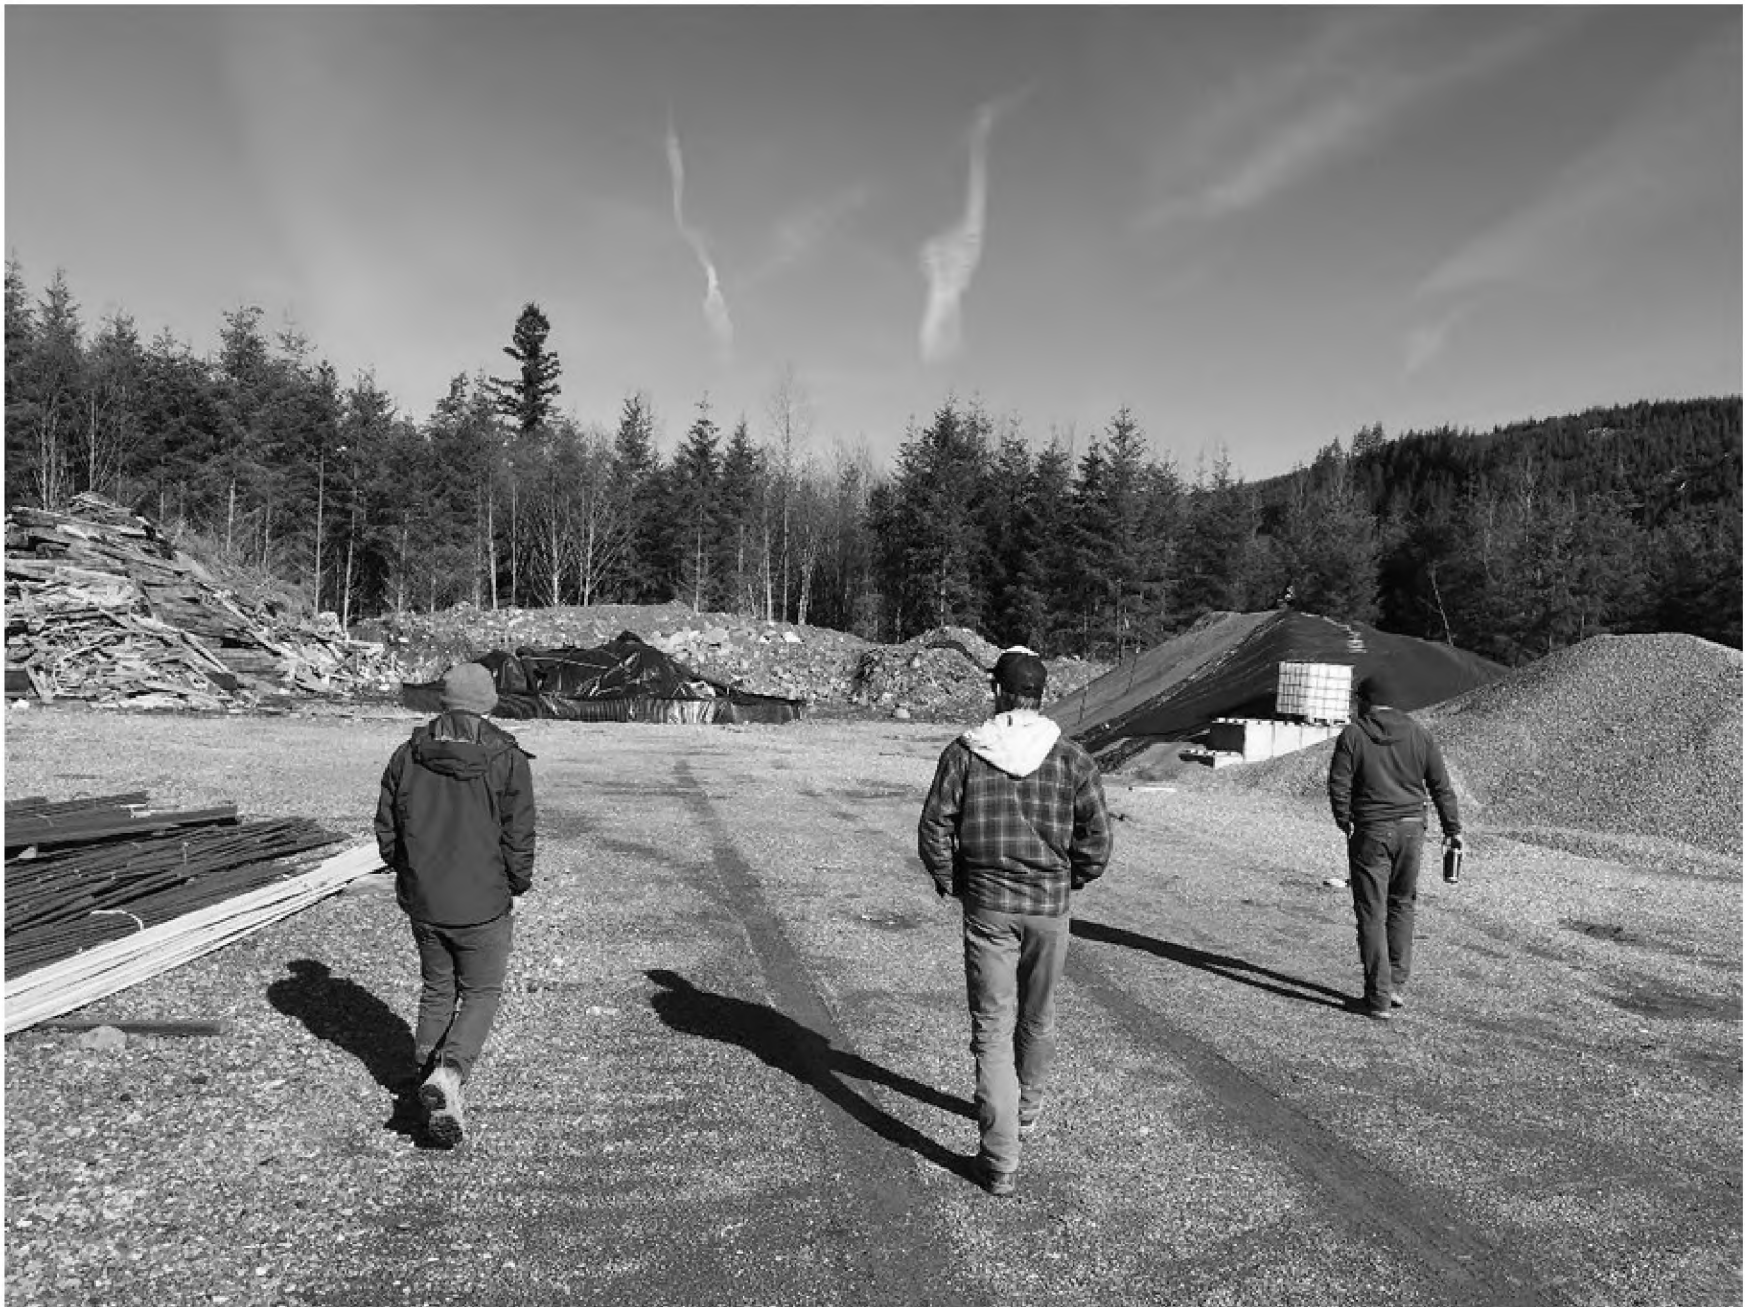
Photo 1

Violations and action required to achieve compliance**Complete or submit date****Guidance****S9.D.5 Stabilize Soils****Bare, unworked Stockpiles**

Failure to meet S9.D.5.a: The Permittee must stabilize exposed and unworked soils by application of effective BMPs that prevent erosion. Applicable BMPs include, but are not limited to: temporary and permanent seeding, sodding, mulching, plastic covering, erosion control fabrics and matting, soil application of polyacrylamide (PAM), the early application of gravel base on areas to be paved, and dust control.

Photo Description: Displaced plastic exposing unworked stockpile at the Intake construction area

Permittee must not allow soils to remain exposed and unworked for more than the time periods set forth below to prevent erosion:
 During the wet season (October 1 - April 30): **2 days** from the date of this inspection.

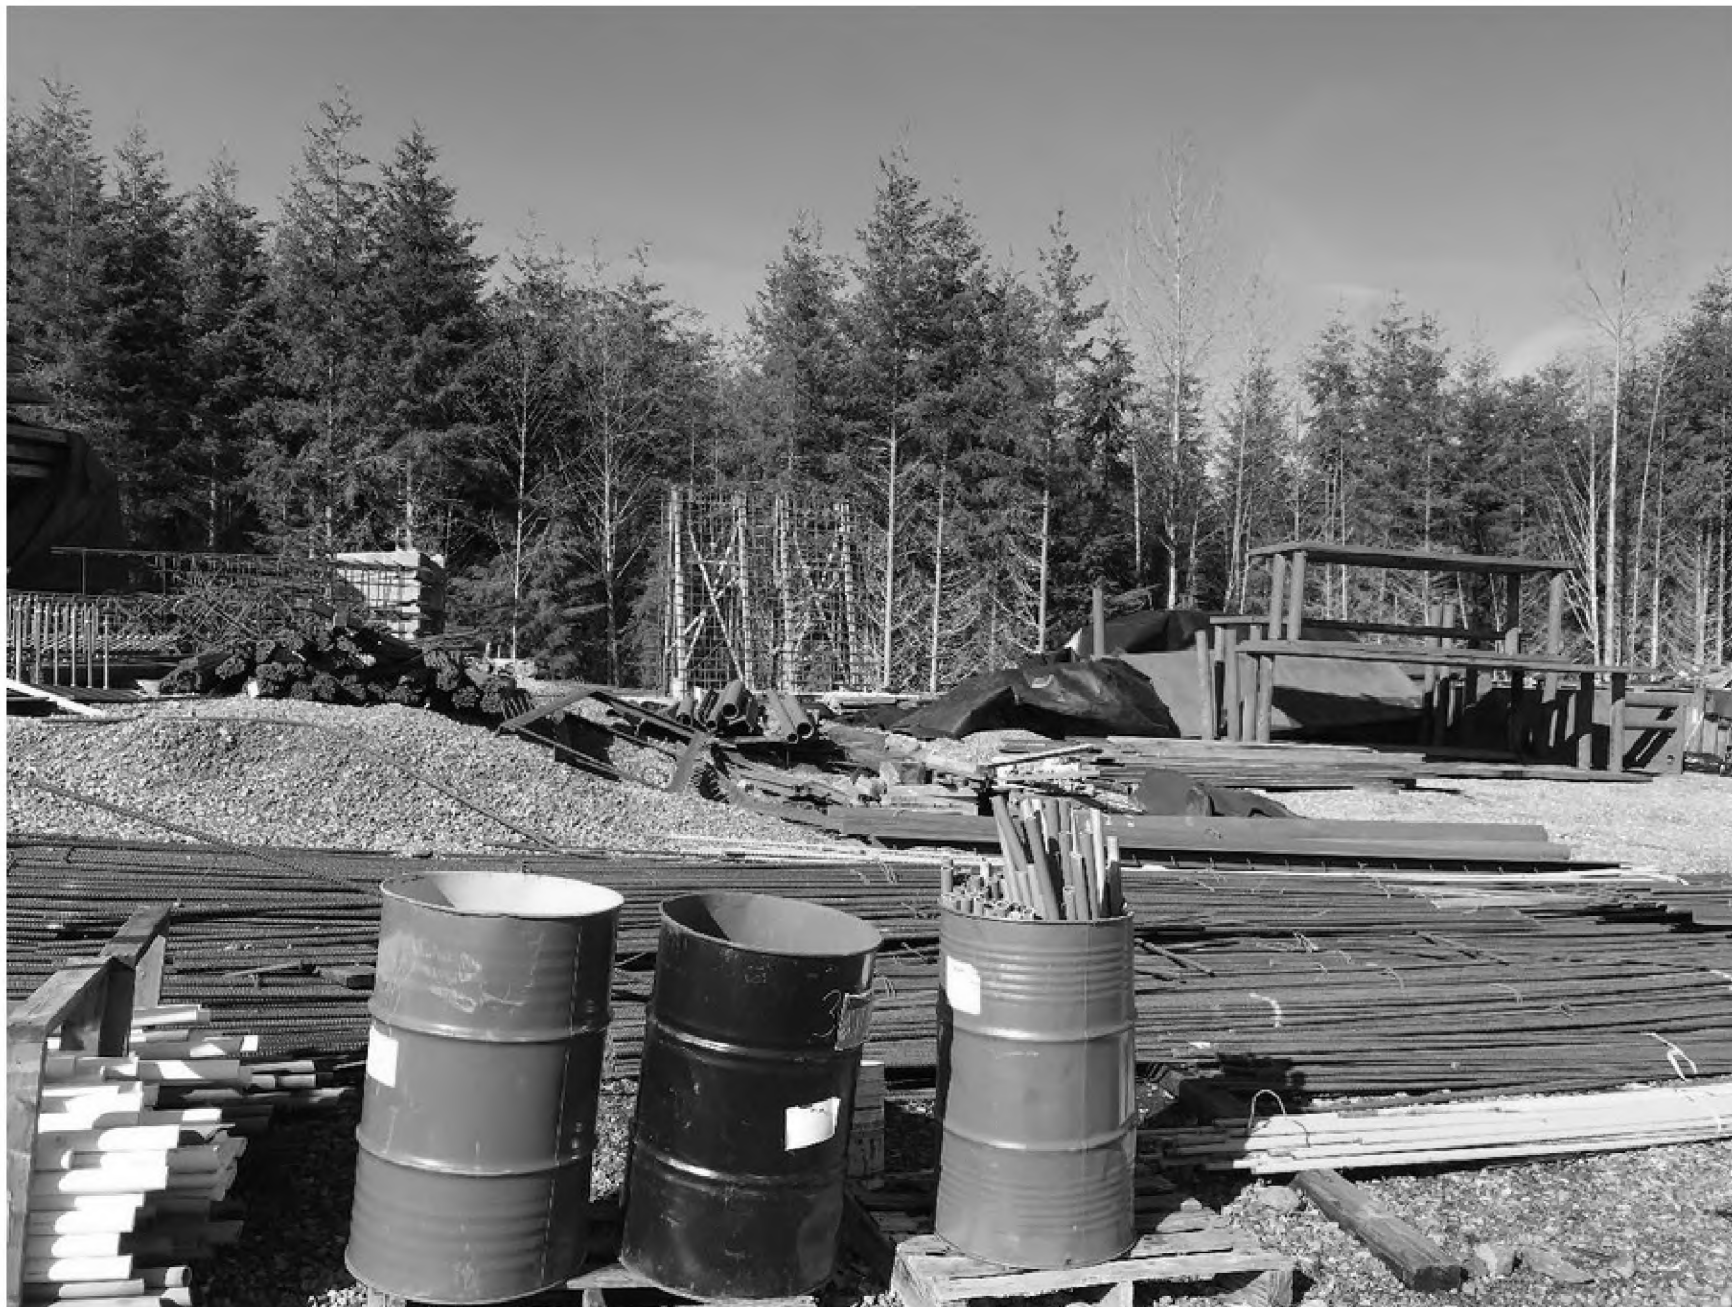
Photo 2

Photo Description: Intake Construction area

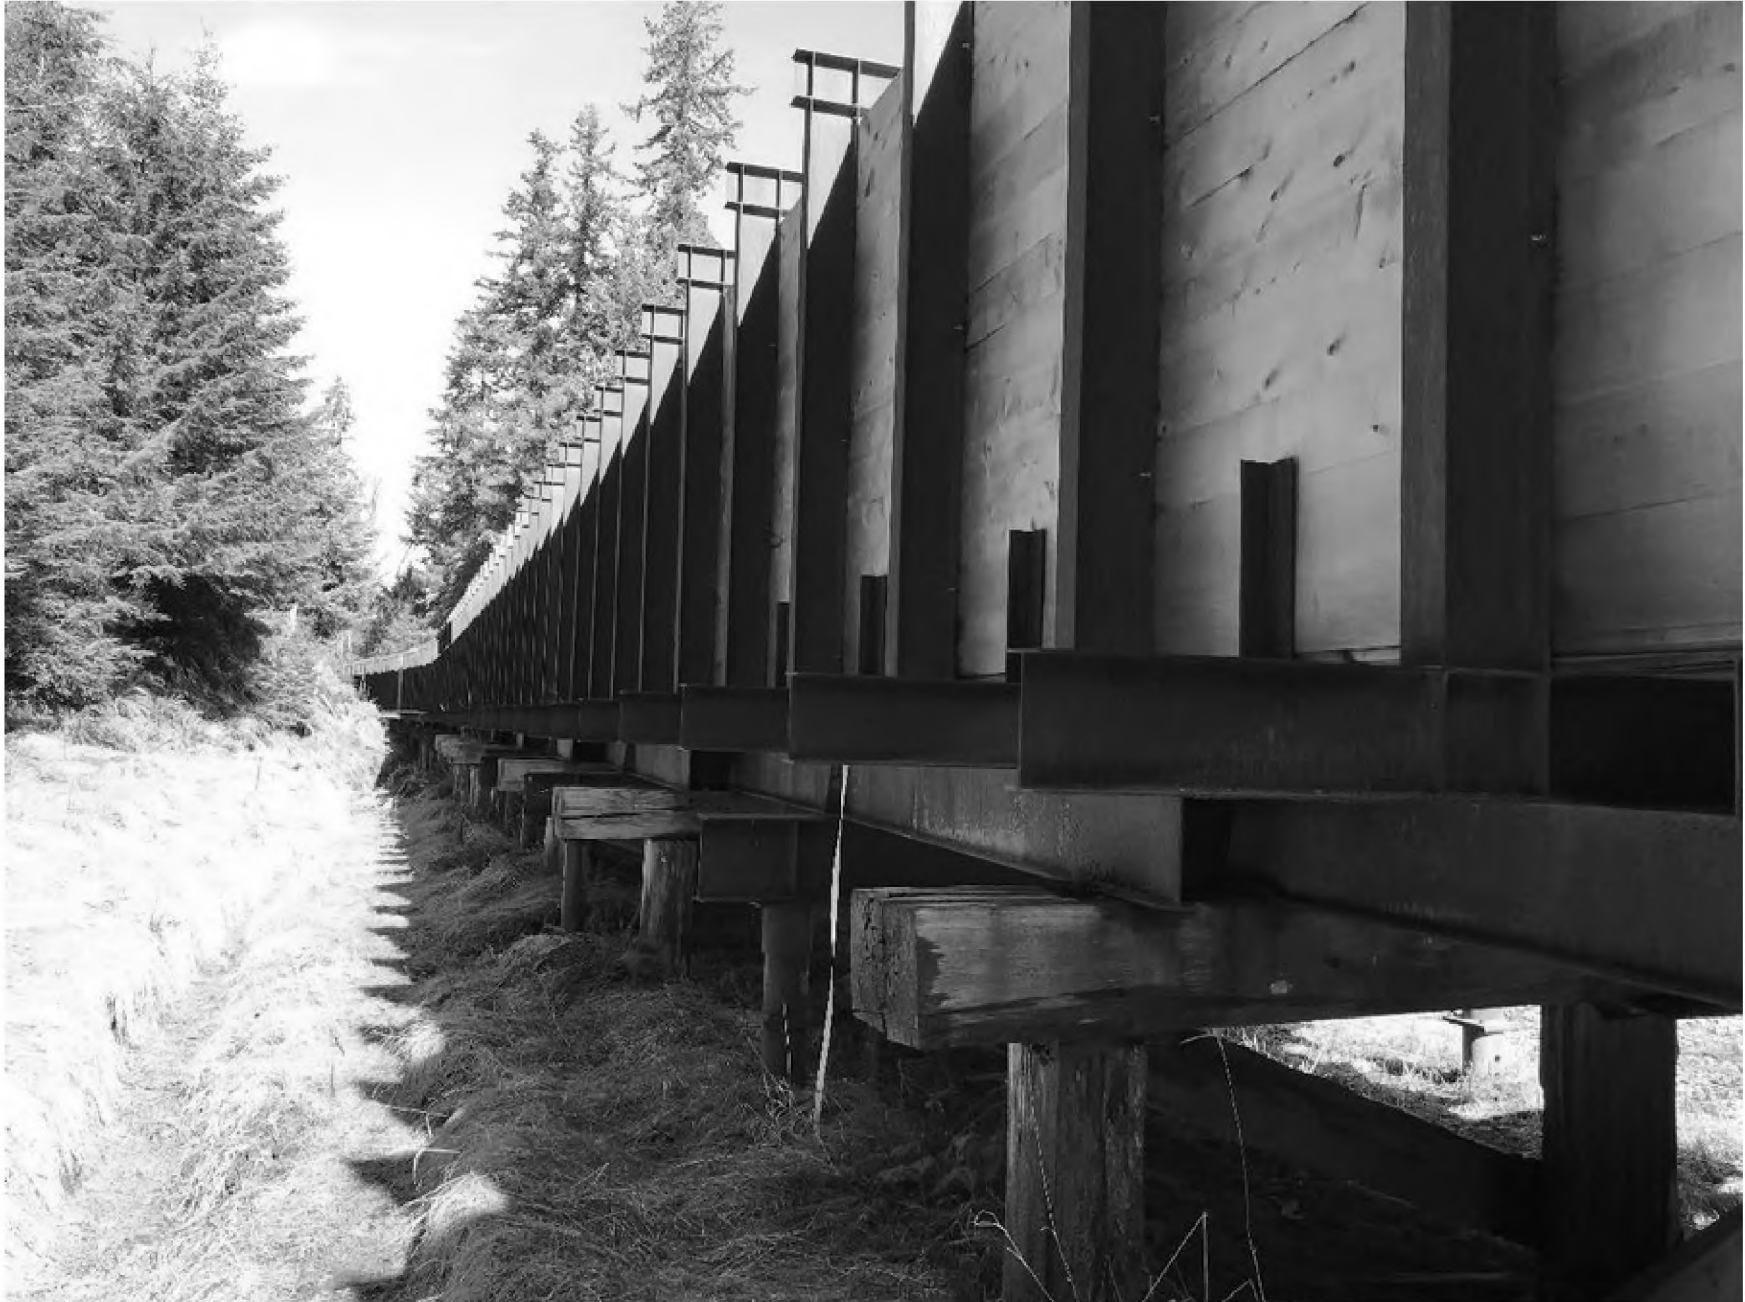
Photo 3

Photo Description: Flume at the Intake area

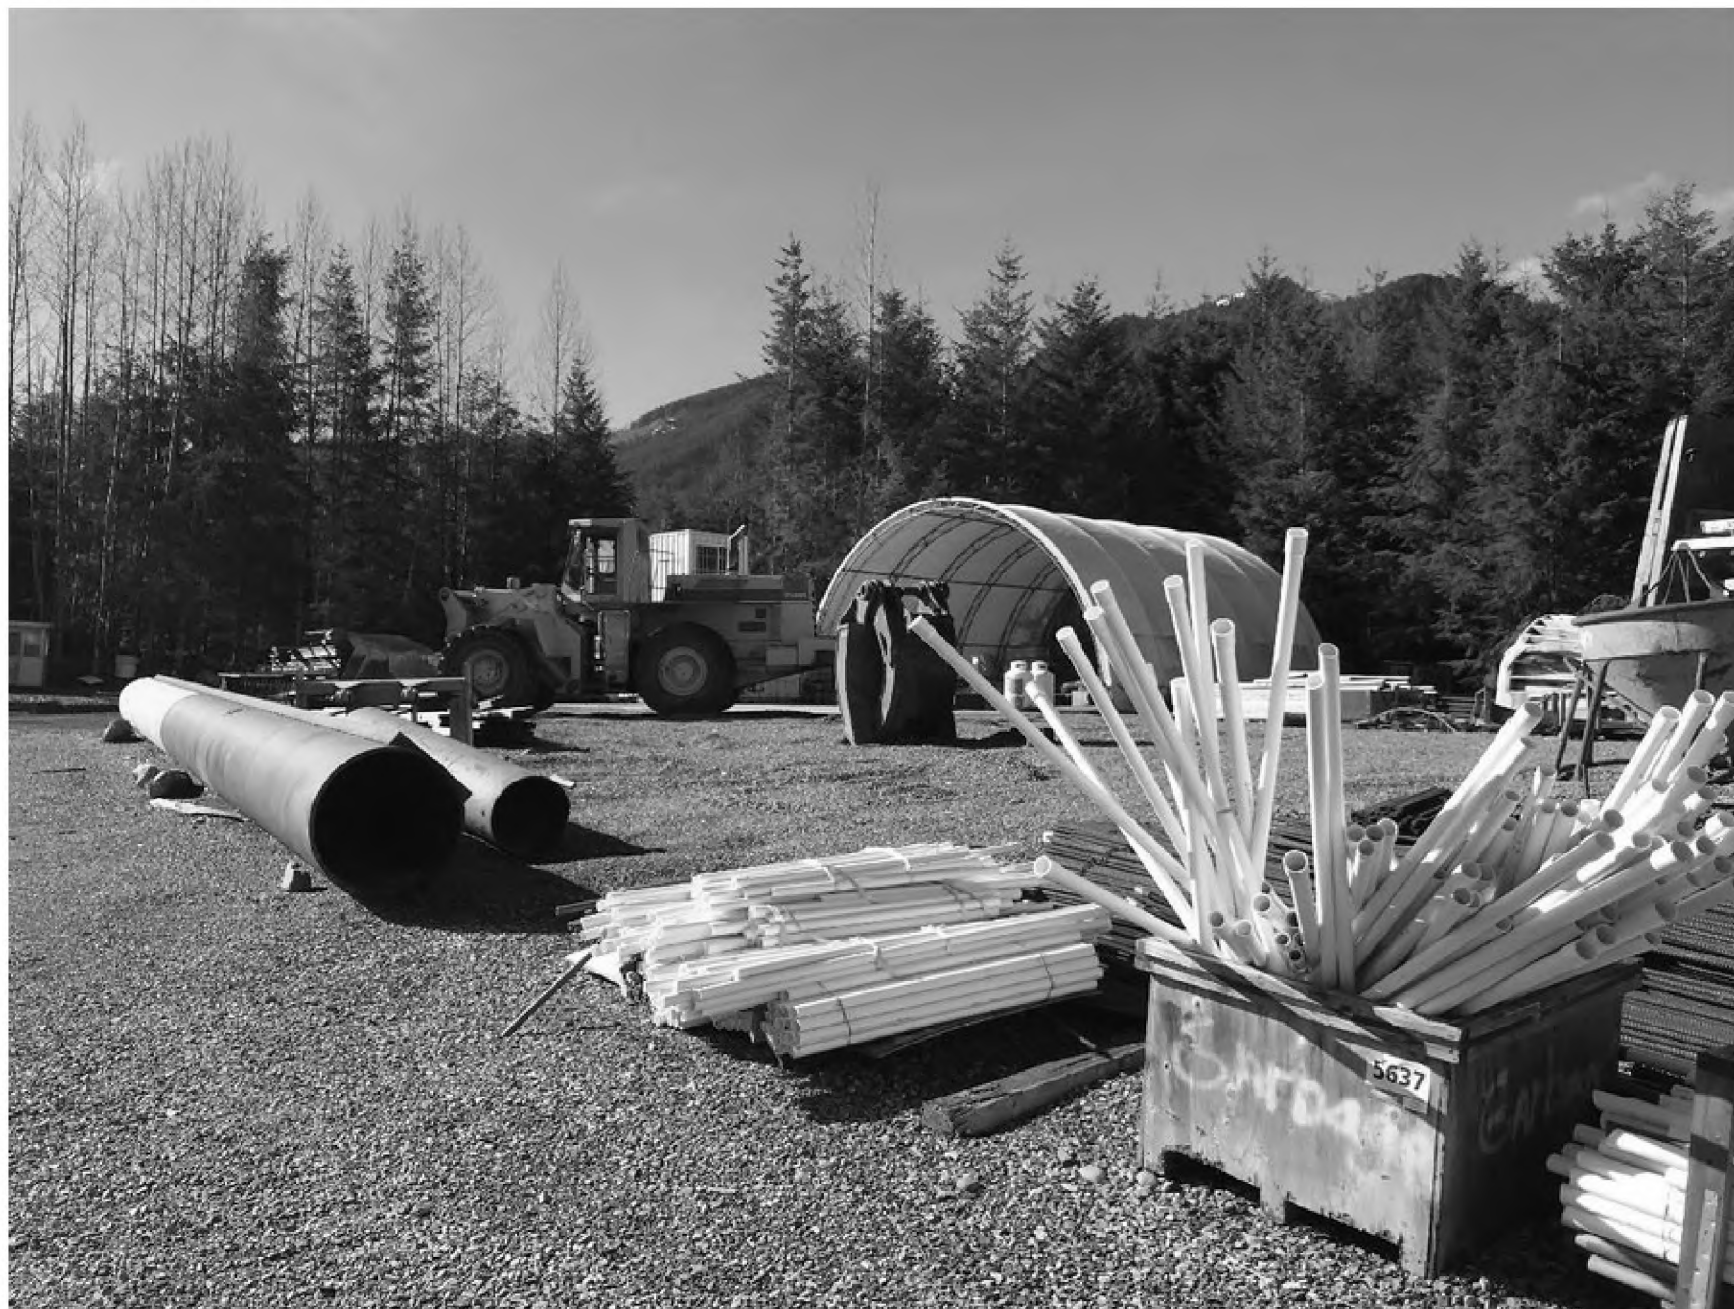
Photo 4

Photo Description: : Intake Construction area

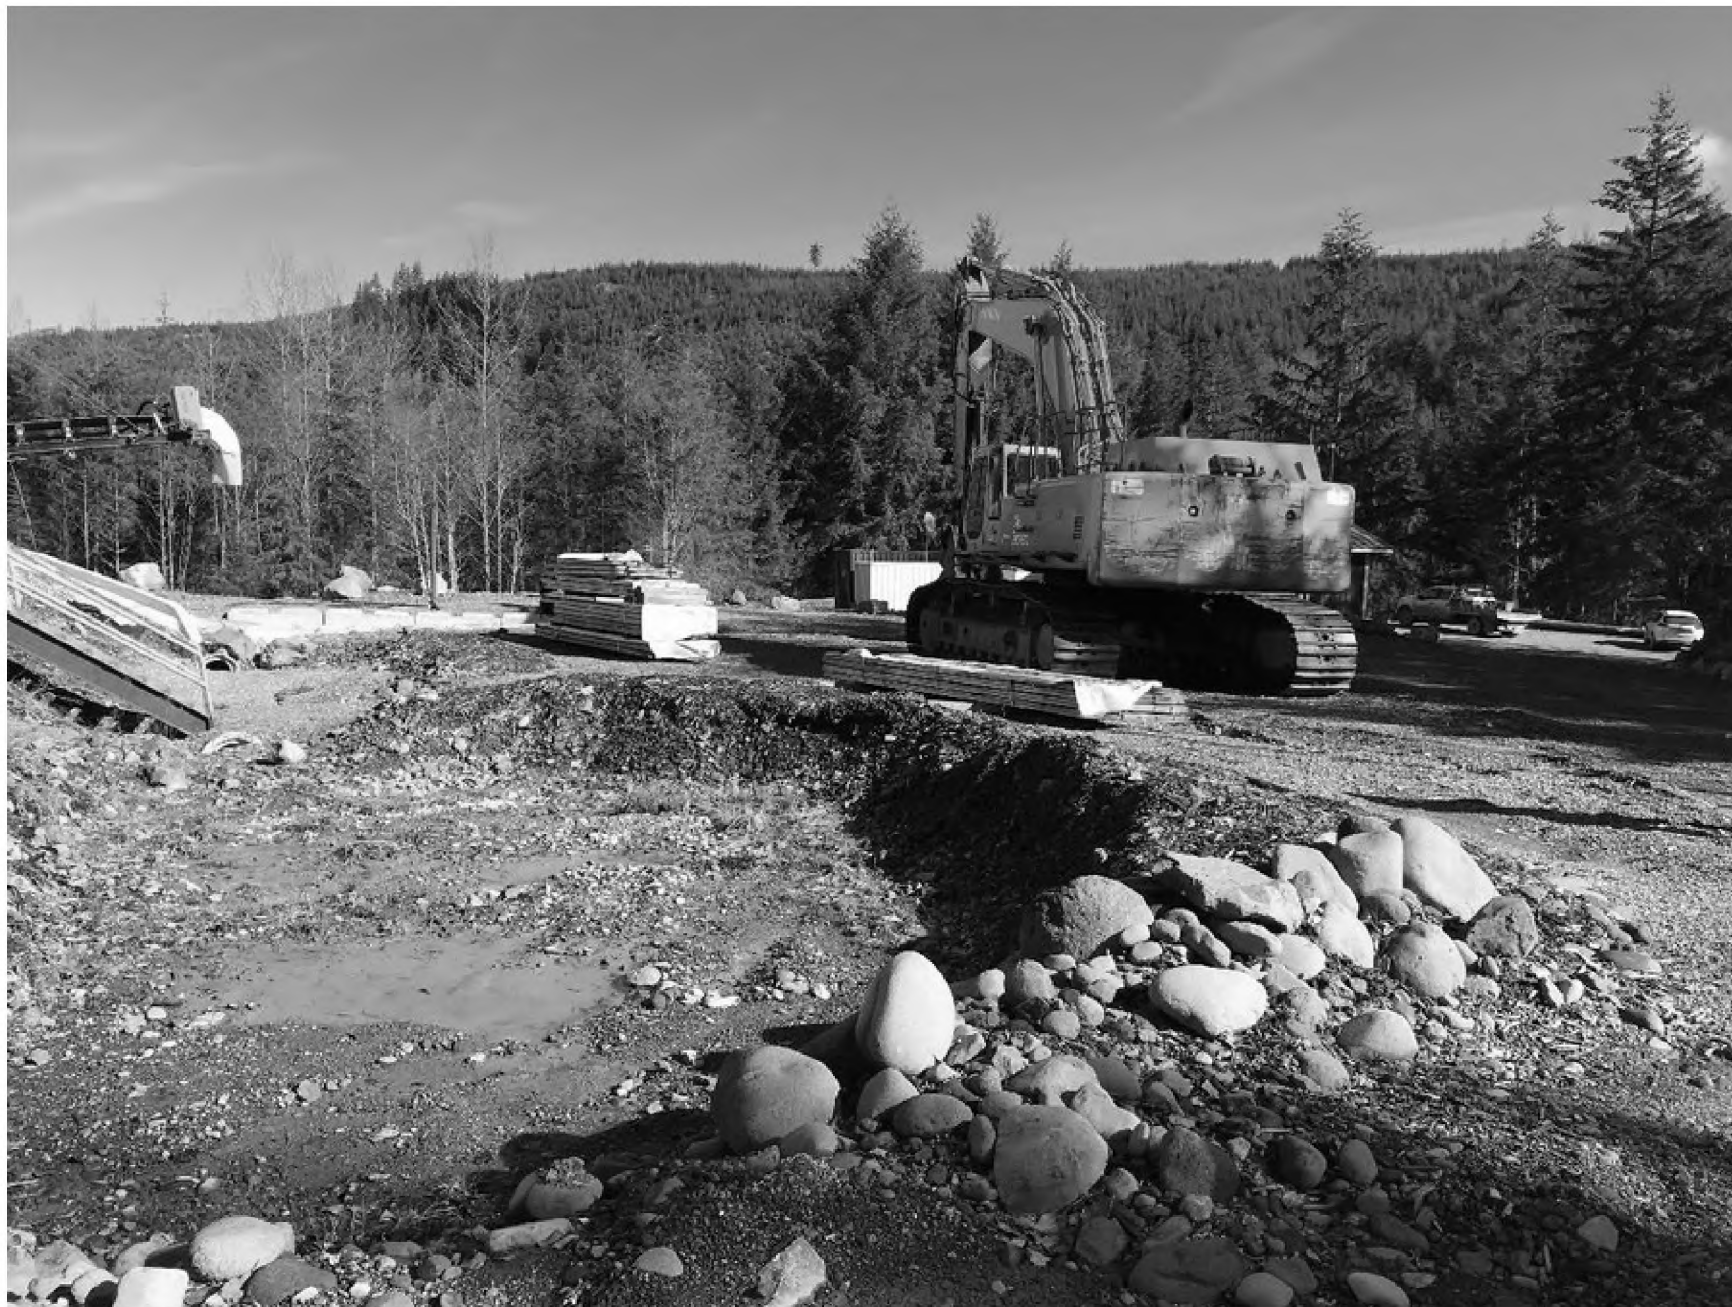
Photo 5

Photo Description: Concrete washout area

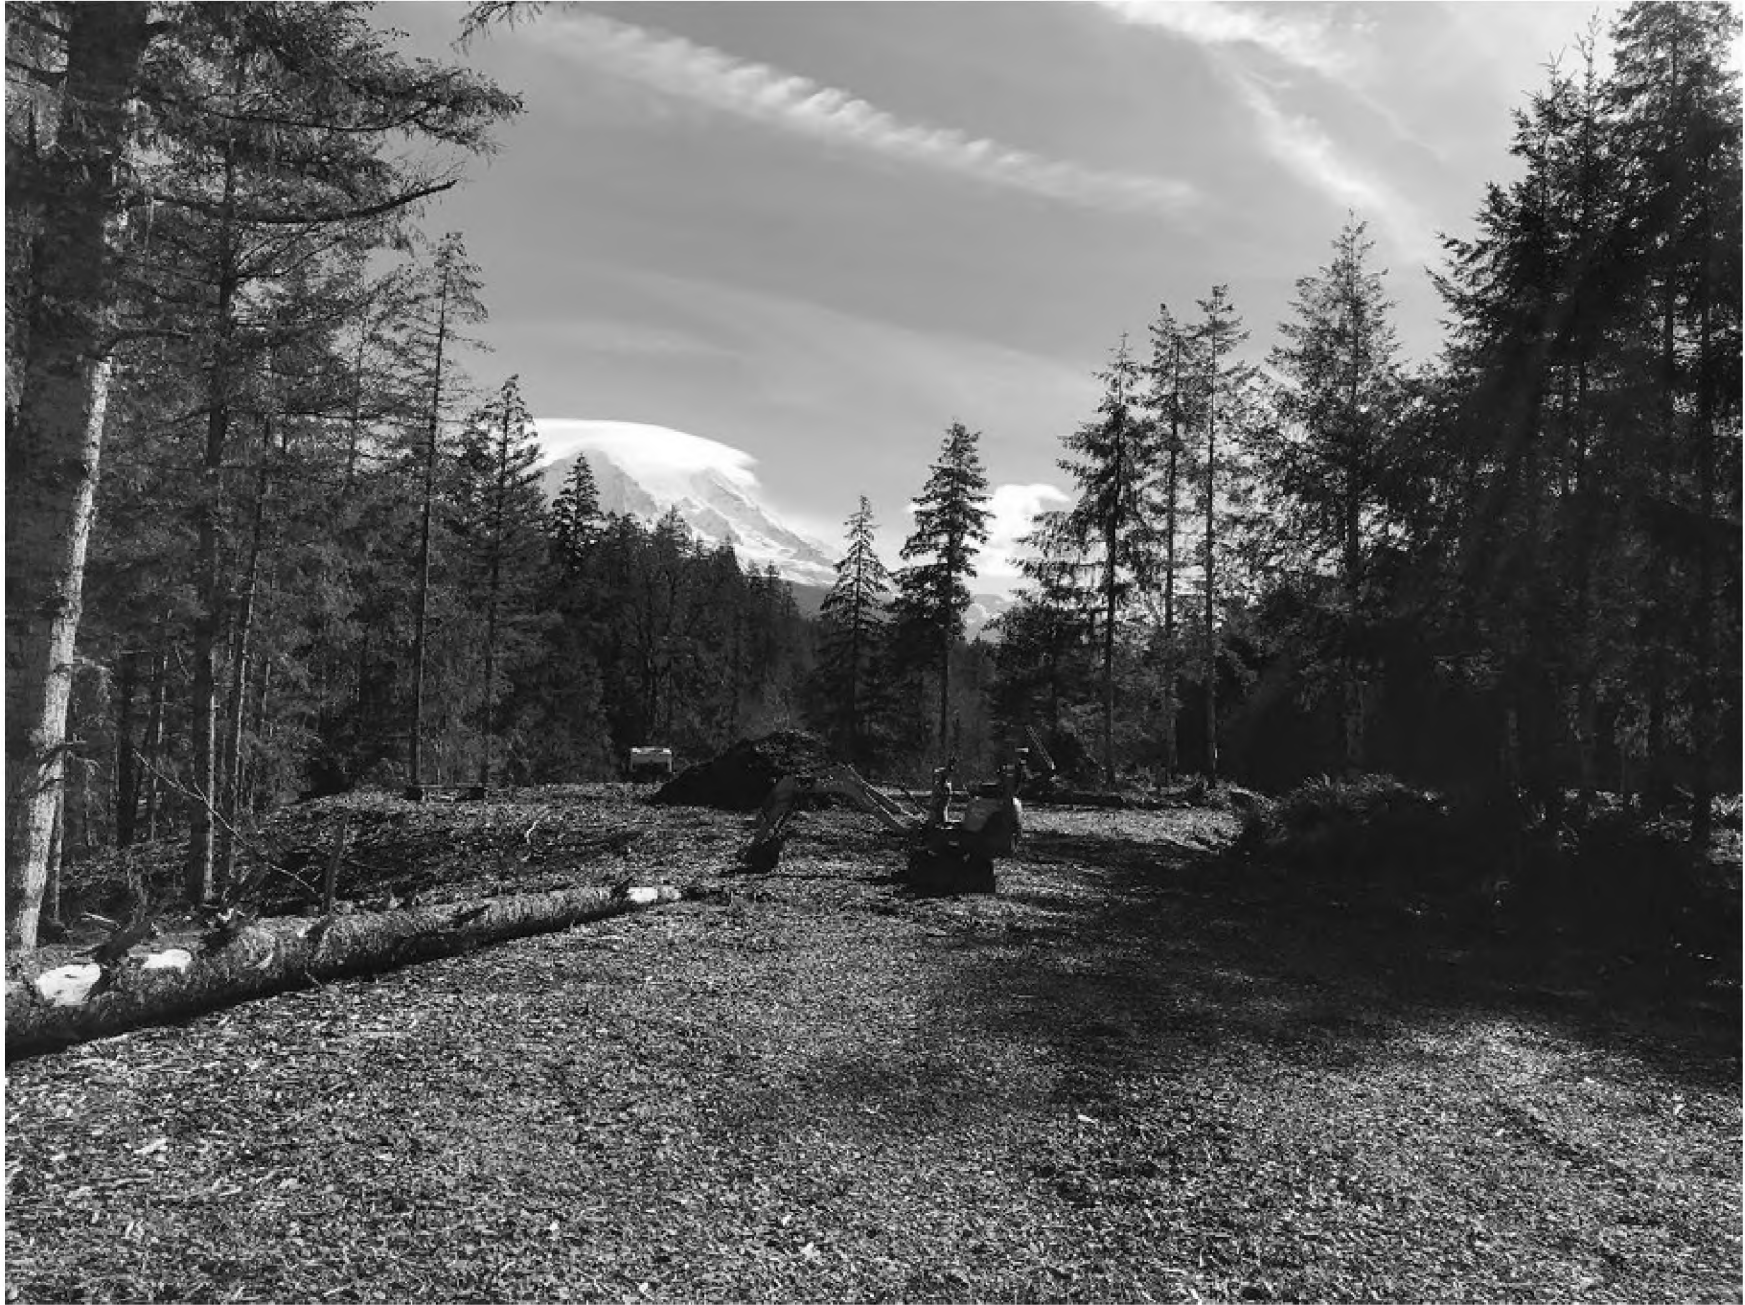
Photo 6

Photo Description: Intake construction area

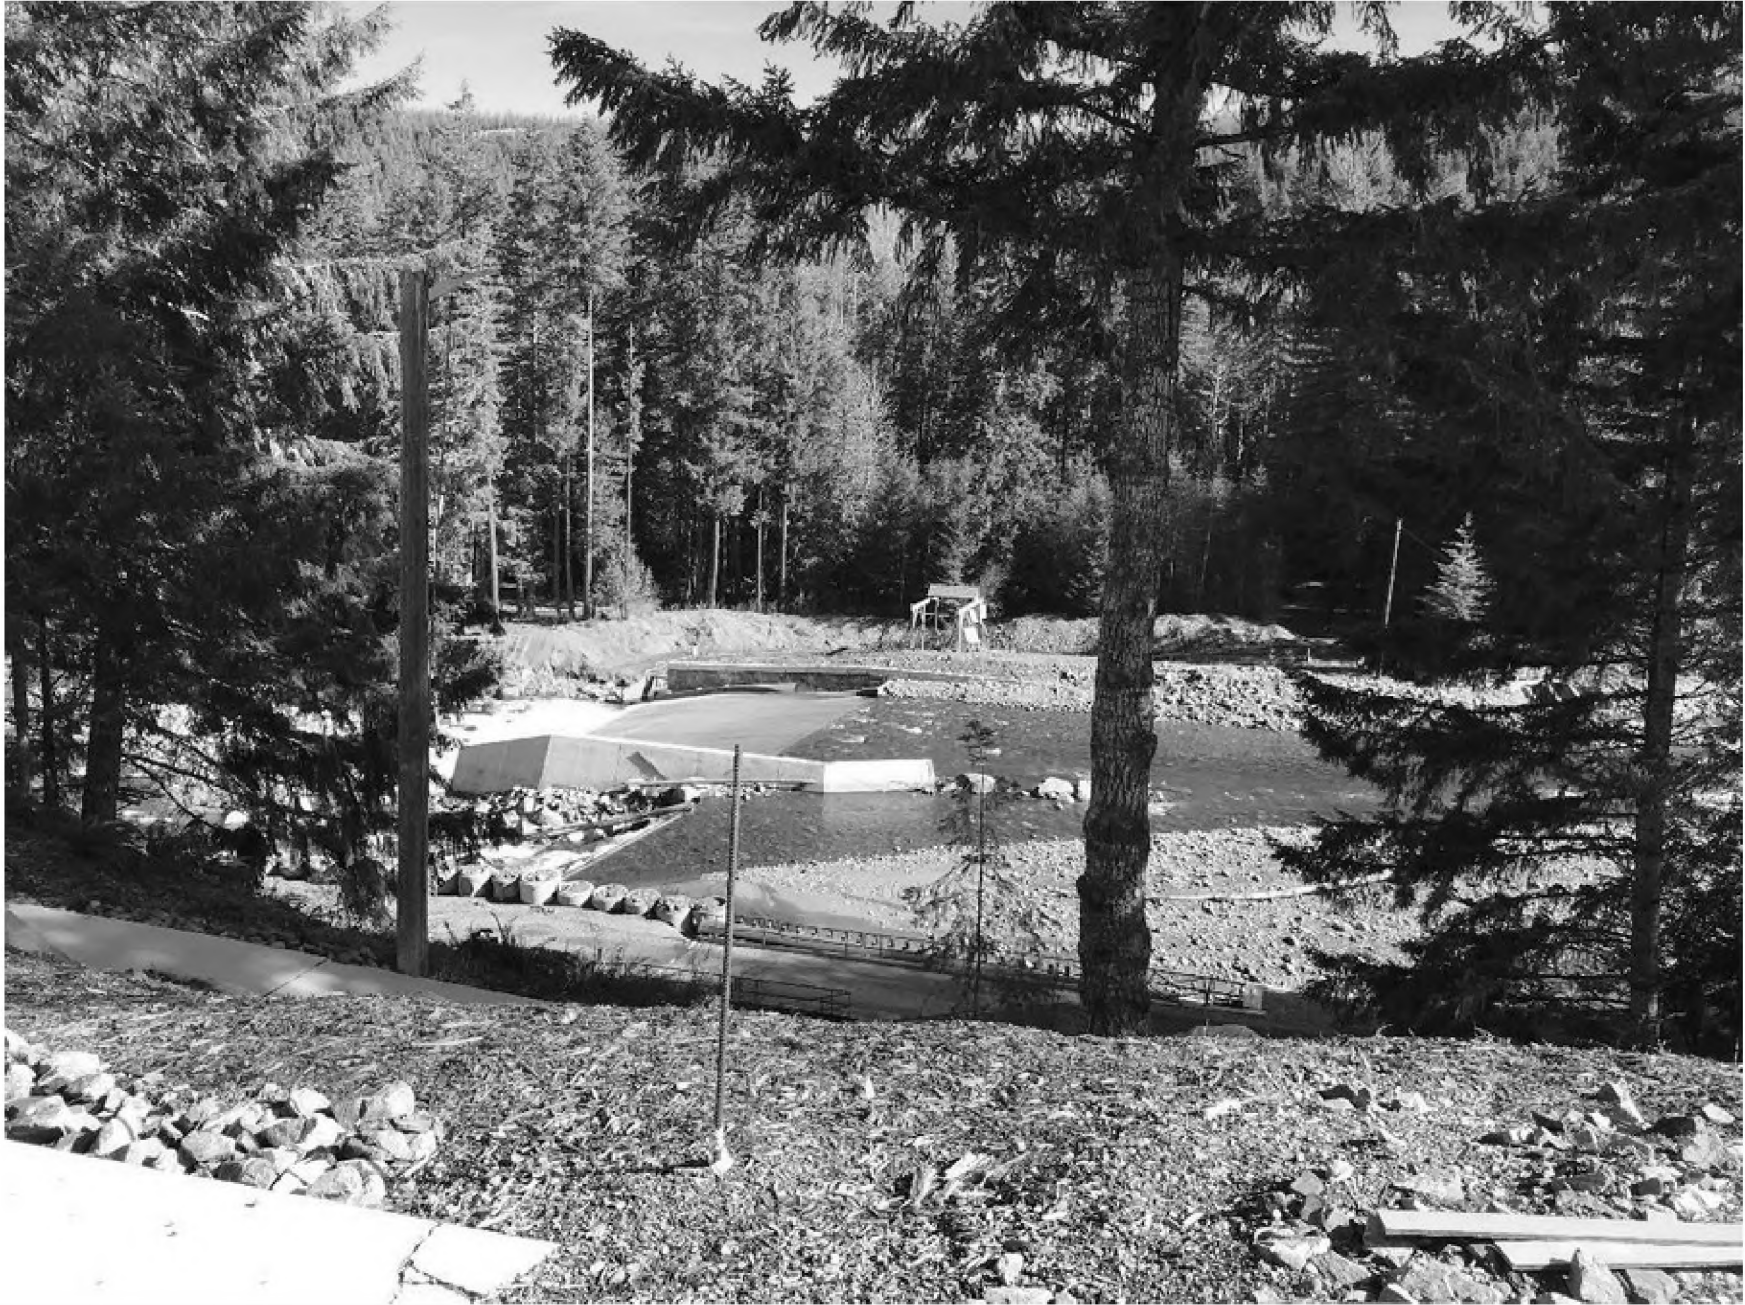
Photo 7

Photo Description: Project intake and Puyallup river

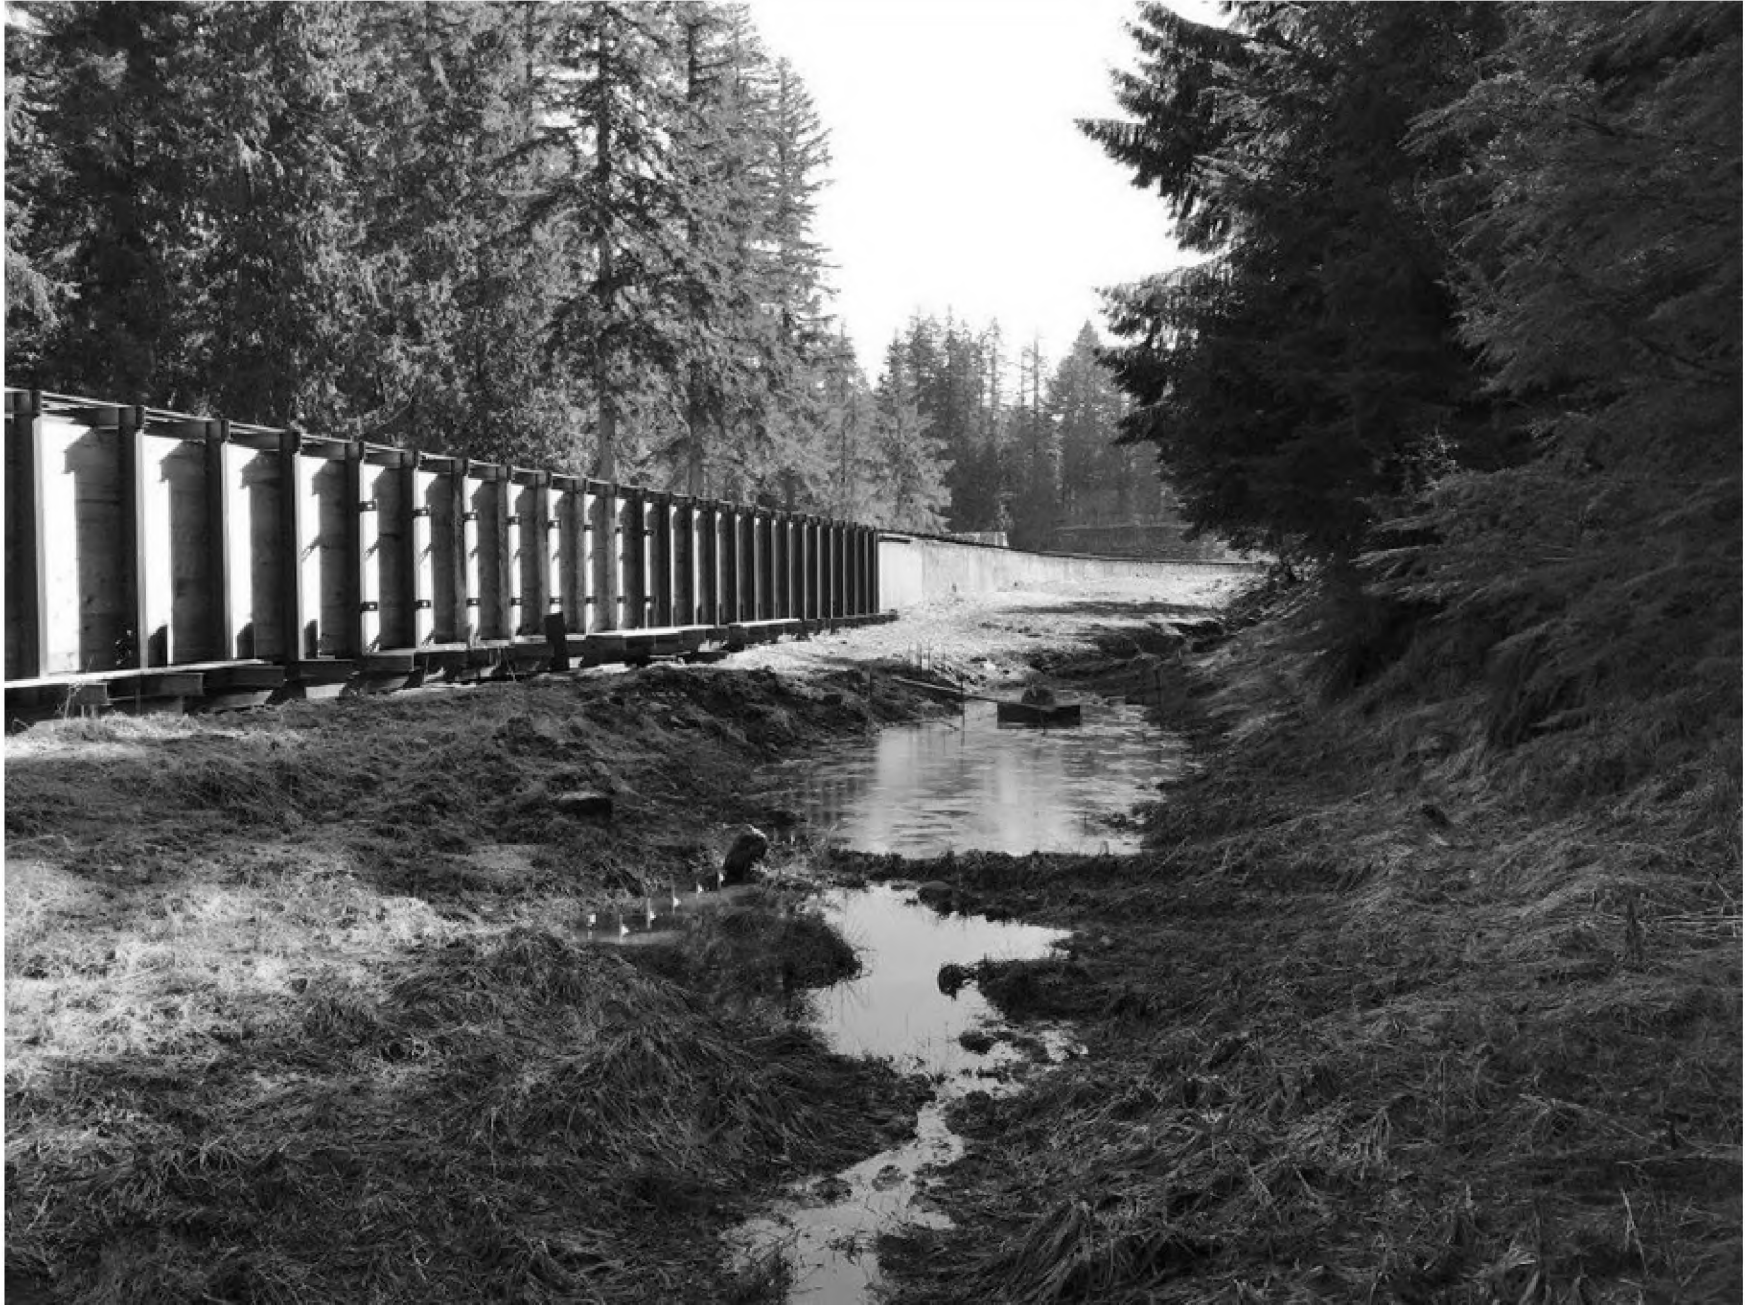
Photo 8

Photo Description: Conveyance channel BMP at the Intake area

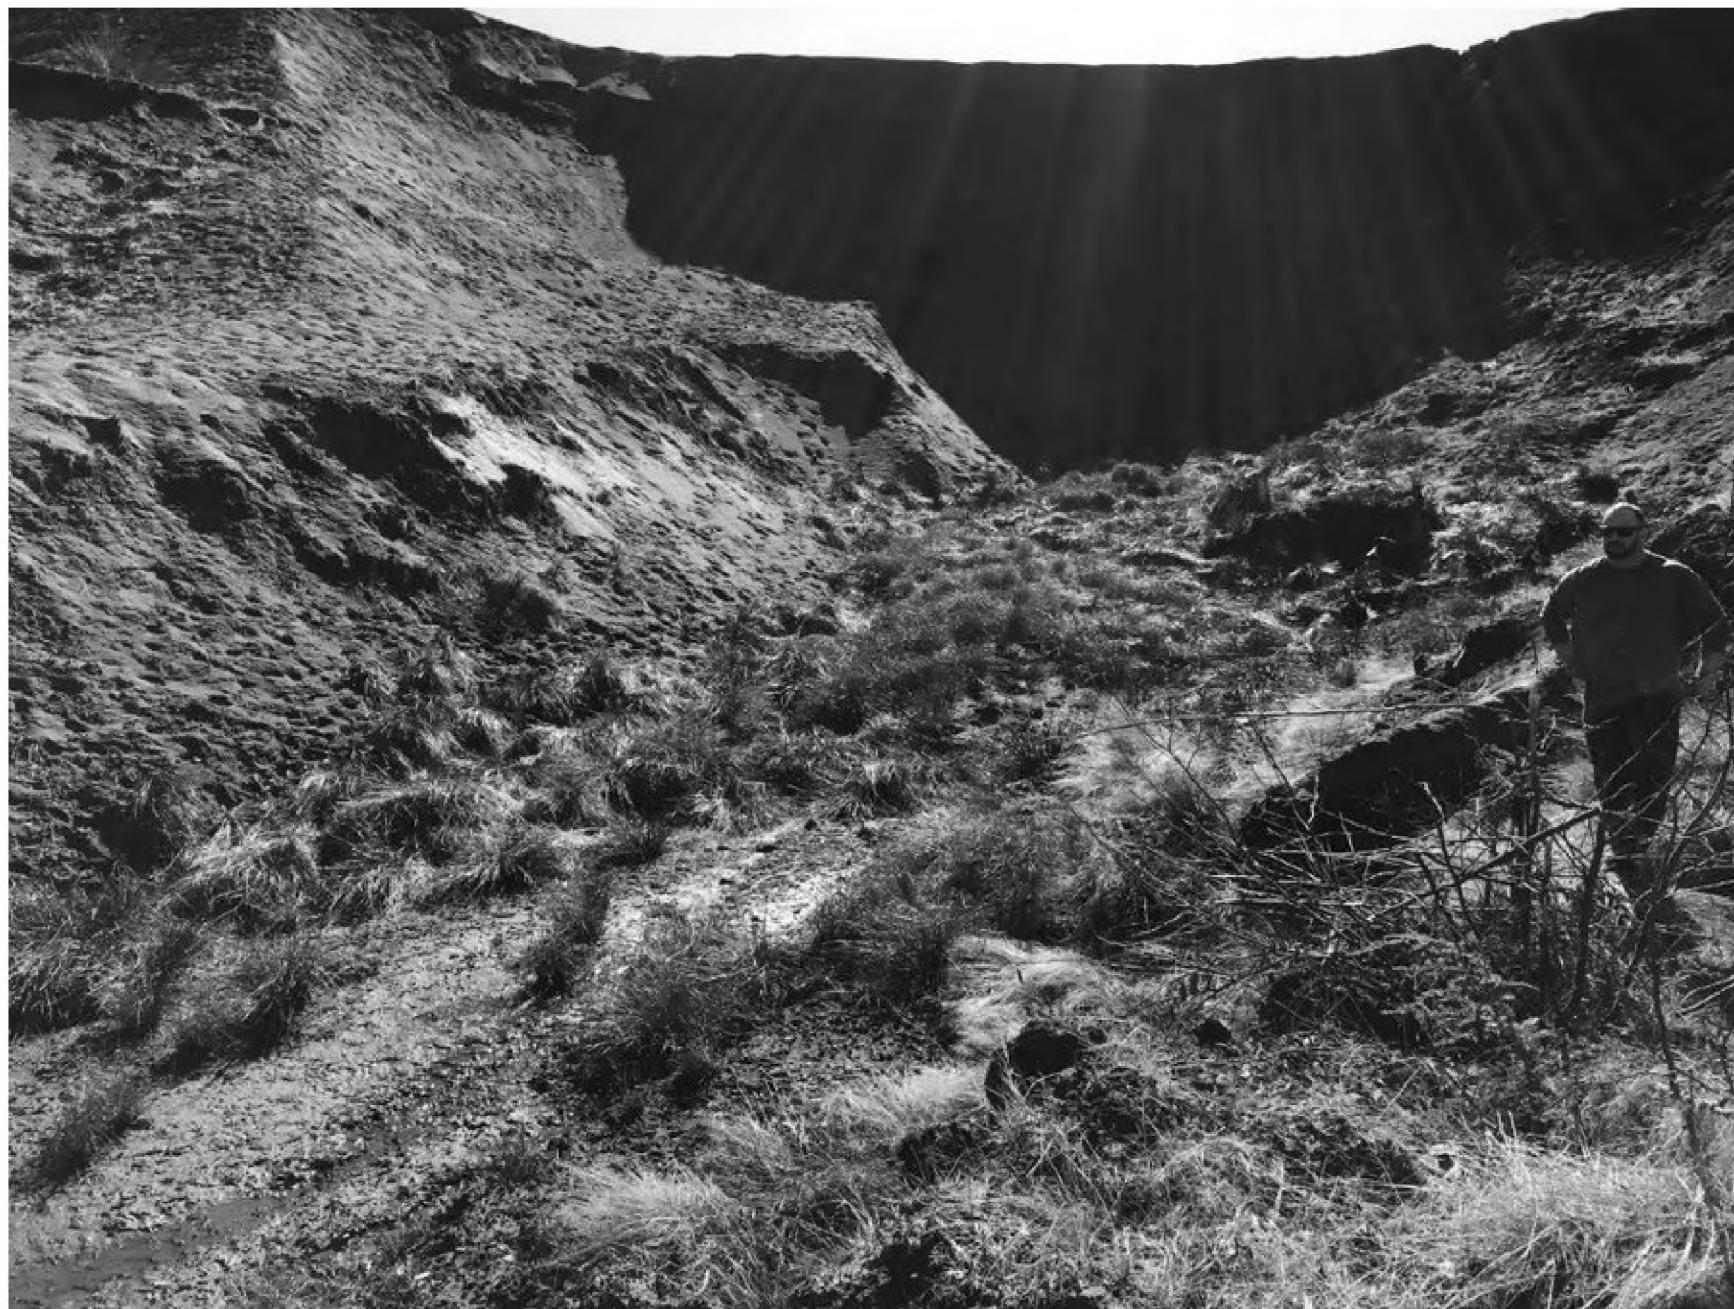
Photo 9

Photo Description: Settling Basin area – photo of the head of the landslide with the creek/seep running from underneath.
